USAFOEHL REPORT
89-003EQ0013ASC

**WASTEWATER CHARACTERIZATION/
HAZARDOUS WASTE SURVEY,
BEALE AFB CA**

January 1989

Final Report

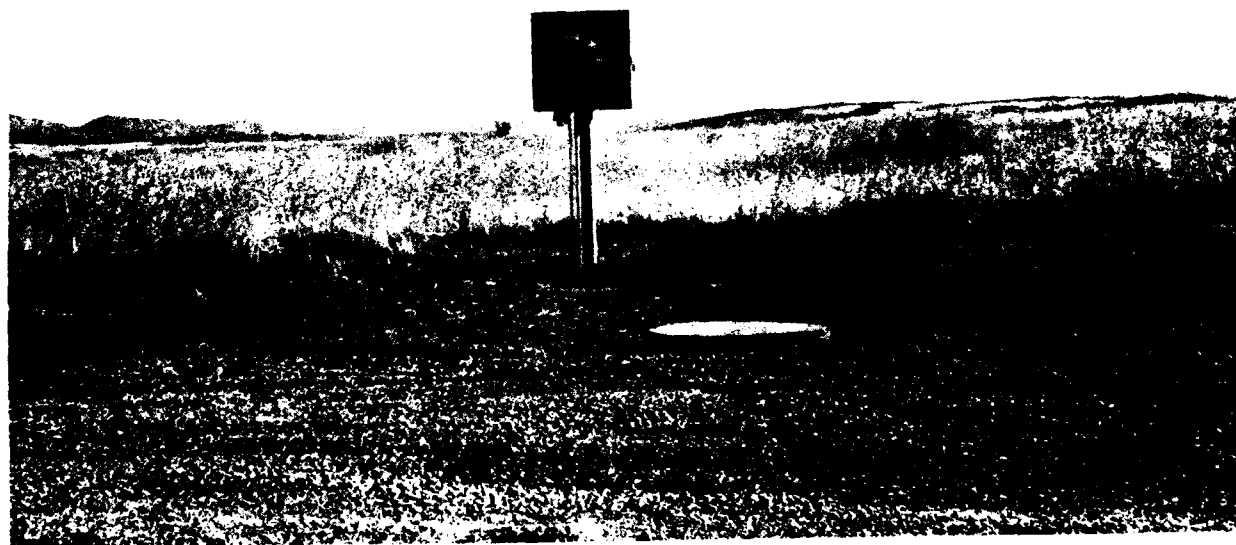
Figure 3: Housing Composite Sampling Site

(1) Site 1, Manhole 953: Boron, cyanide and surfactants were detected in the composite sample from the housing area, clinic and PAVE PAWS. The STP effluent limits for cyanide was exceeded. The average boron, cyanide and surfactant concentrations were 0.5, 0.009 and 53.3 mg/L, respectively. The average flow was 0.58 MGD. Sources of boron are developers and fixers used in x-ray film developing at the Clinic and cleaning soaps. The only source of cyanide found was laundry detergent. Surfactants (MBAS) are used in soaps to aid in cleaning. Site 1 is presented in Figure 3.

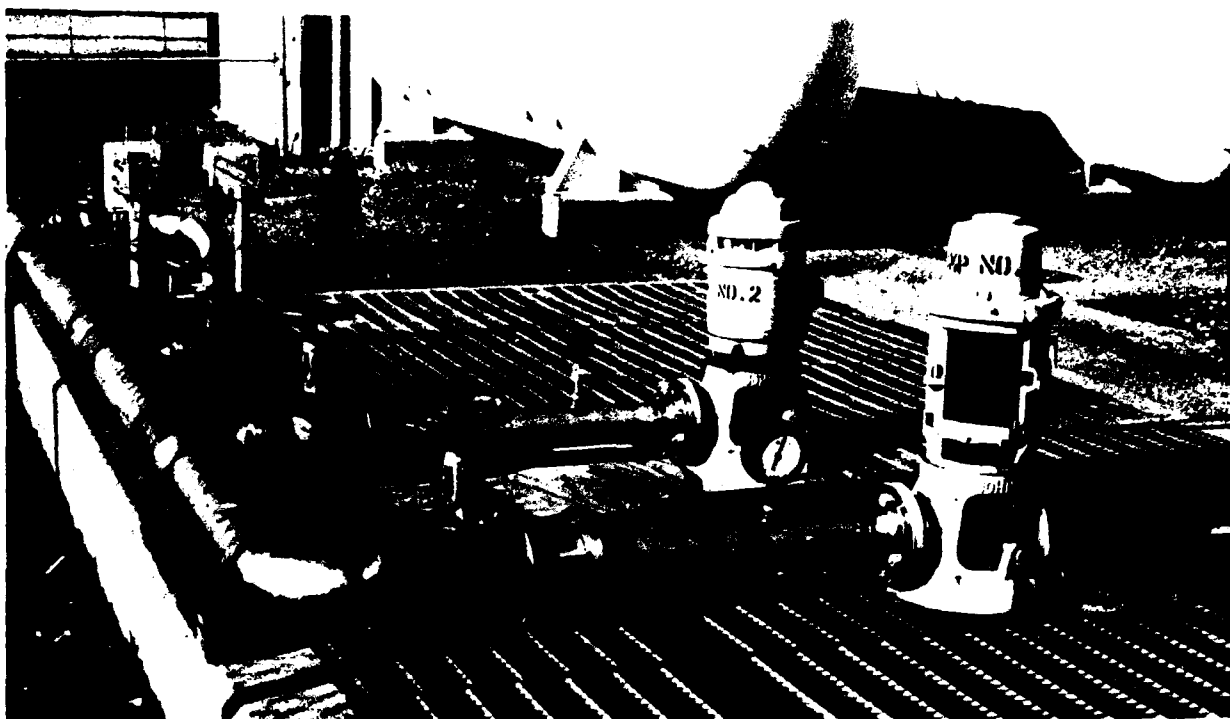
Figure 6. 9 RTS Precision Photo Lab Wet Well

(5) Site 5, Manhole 310: Boron, cyanide and surfactants were detected in the wastewater from the the 9th RTS Precision Photo Lab. Boron, cyanide and surfactant concentrations were 2.7, 0.068 and 0.3 mg/L, respectively. The flow was intermittent and beyond our capability to accurately measure. Contaminants associated with film processing chemicals such as cyanide and boron are obviously present in the sanitary sewer. However, how the chemicals entered the sewer is not obvious. The waste is either being discharged directly to the sanitary sewer through floor drains in building 2145 or is leaching from the photo wet well into the adjacent sanitary sewer line.

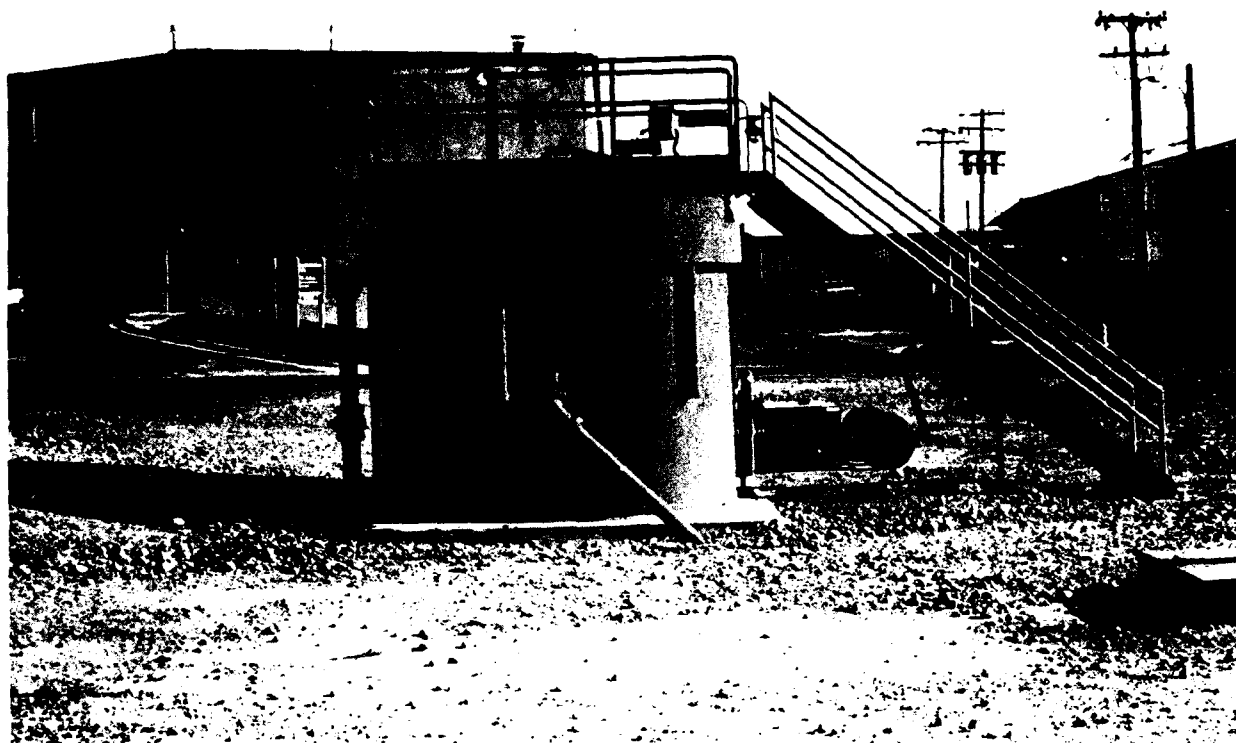
Figure 9. Washrack Oil/Water Separator

Shop personnel are responsible for washing KC-135 (1/week) and TR-1 (1/month) aircraft. Other shops wash U-2 (1/month) and SR-71 (1/week) aircraft at the washrack. Safety Kleen Soap (5 gallons/month) is mixed at a 1:2 ratio for washing the SR-71. PD-680 (150 gallons/month), Pen Air M-5572 (100 gallons/month), and Aircraft Cleaning Compound (NSN 6850 01184 3182 - 100 gallons/month) are used for washing the other aircraft. Both soaps are mixed at a 1:5 ratio. The soap is normally applied with a pressure cleaner; however, when the machine is not working the soap is applied by hand. Applying the soap by hand usually requires more soap. In the future, PD-680 will be replaced with Citrikleen. The drains lead to an oil/water separator that is cleaned out every two years by shop personnel (See Figure 9). Sludge from the separator is pumped into a bowser and eventually into 55-gallon drums.

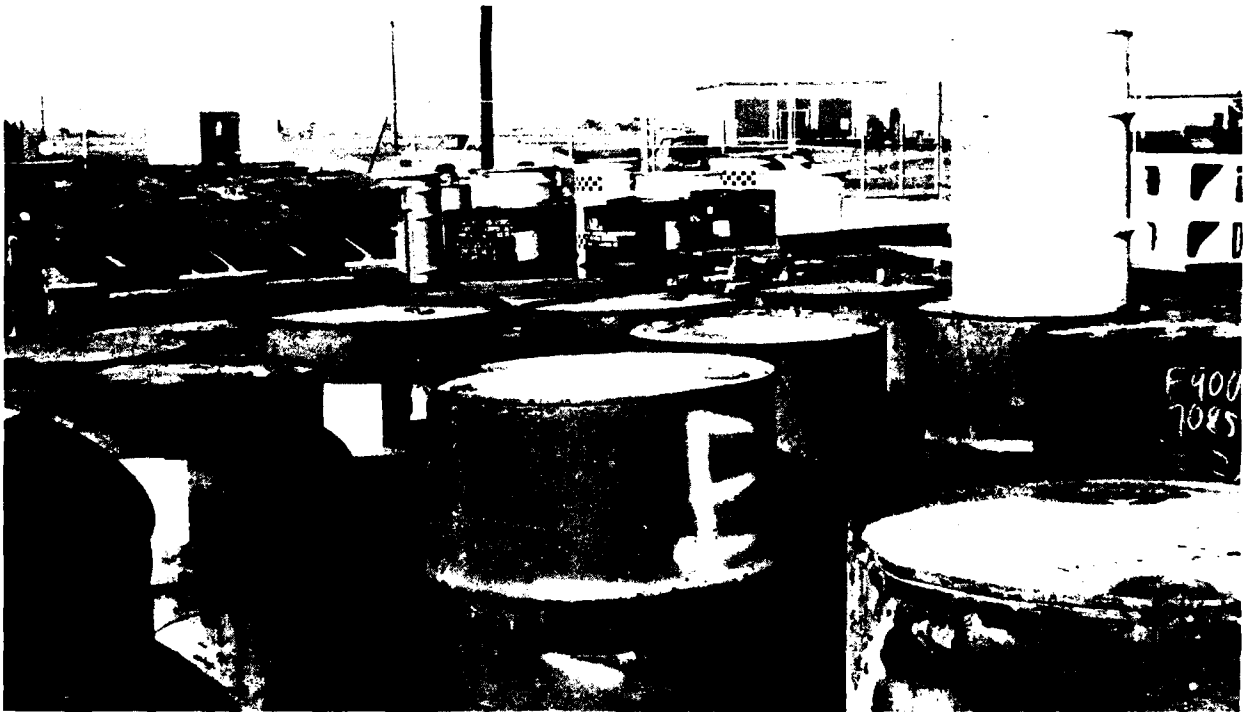
Figure 10. Civil Engineering Accumulation Site

This accumulation site is used for storage of wastes generated at Civil Engineering shops (See Figure 10). All waste oils and fluids are taken to the used oil storage tank at the Transportation Complex.

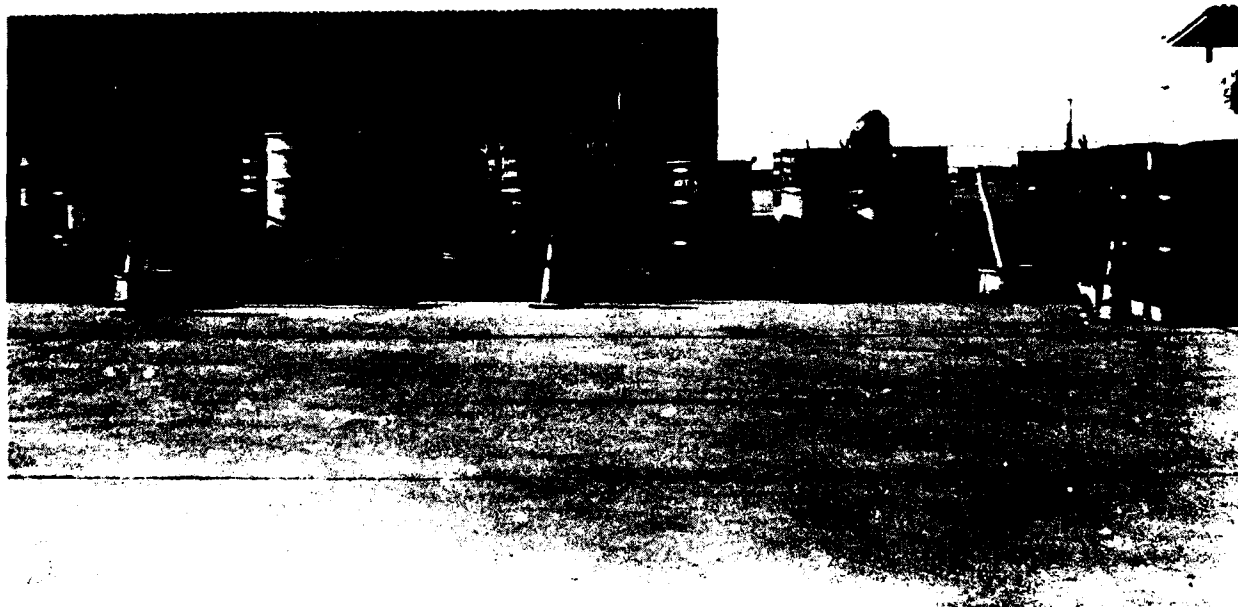
Figure 11. OMS Accumulation Site

The OMS Accumulation Site is located at the washrack (See Figure 11). The site also serves as the KC-135 Phase Dock generation point. The area is situated on a concrete pad adjacent to the flight line. At the time of the survey, washrack sludge (from the oil/water separator), waste JP-7, JP-4, and 7808 oil were being accumulated at the site. All drums are stored on pallets. The site has a 2000-gallon above ground tank that is used for the storage of used oils and fluids from the flight line. The oils and fluids are first placed in a drum at the generation point, transported to the site, and pumped into the tank. The tank is pumped out approximately every two months by a contractor. A work order has been submitted to construct a dike around the tank.

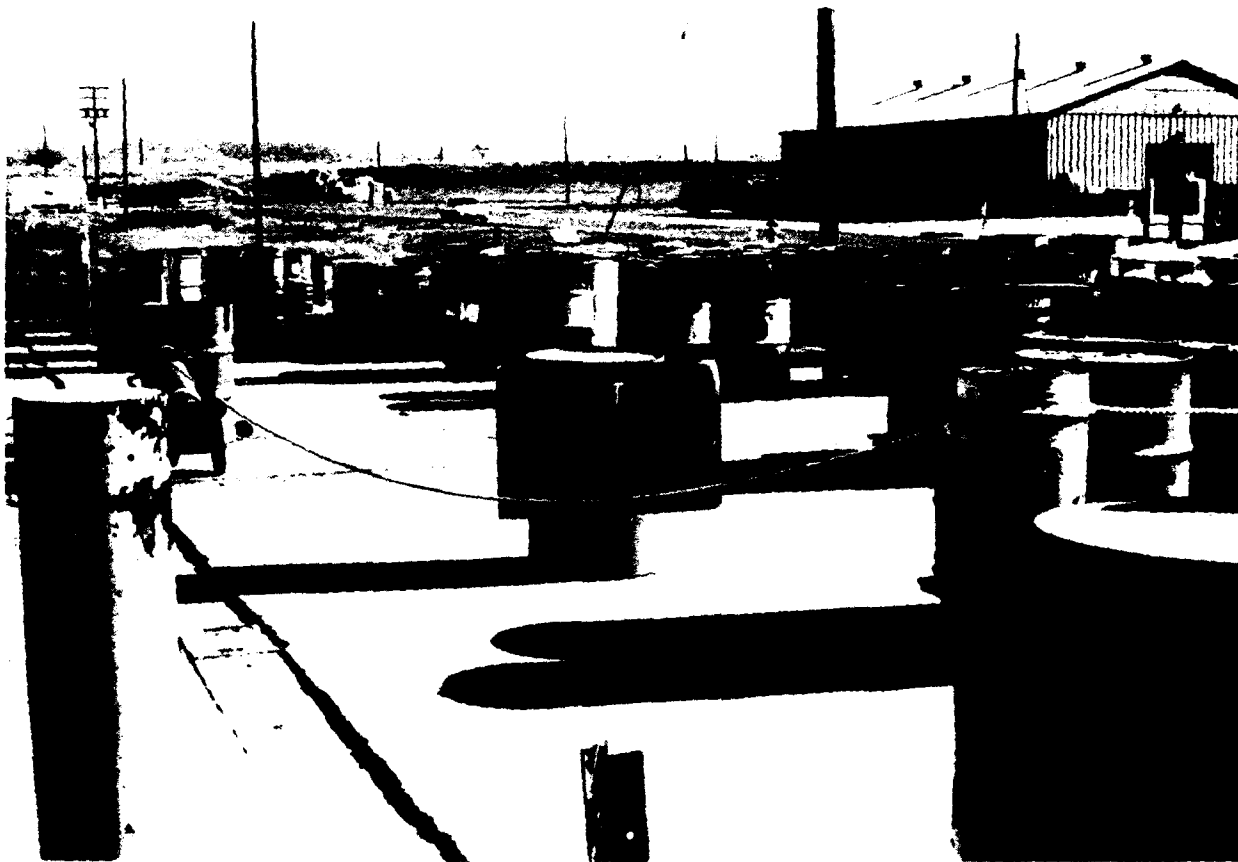
Figure 12. FMS Accumulation Site

The FMS Accumulation Site is located on an uncovered concrete storage pad (See Figure 12). At the time of the survey, waste MEK, JP-7, NDI developer, Speedy Dry and Citrikleen were being accumulated at the site. All drums are stored on pallets. No plans have been made for upgrading the site. Used oils and fluids generated at FMS shops are accumulated in drums, taken to the OMS Accumulation Site, and pumped into the used oil storage tank.
